Failure Patterns of Severely Compromised Endodontically Treated Anterior Teeth: A Comparative *In Vitro* Study of Two Restorative Approaches

Introduction: This *in vitro* study aimed to compare the failure patterns of two restorative techniques in severely damaged, endodontically treated maxillary central incisors: (1) endocrowns fabricated from lithium disilicate ceramic (IPS e.max Press), and (2) quartz-fiber posts with composite resin cores and lithium disilicate crowns (IPS e.max Press).

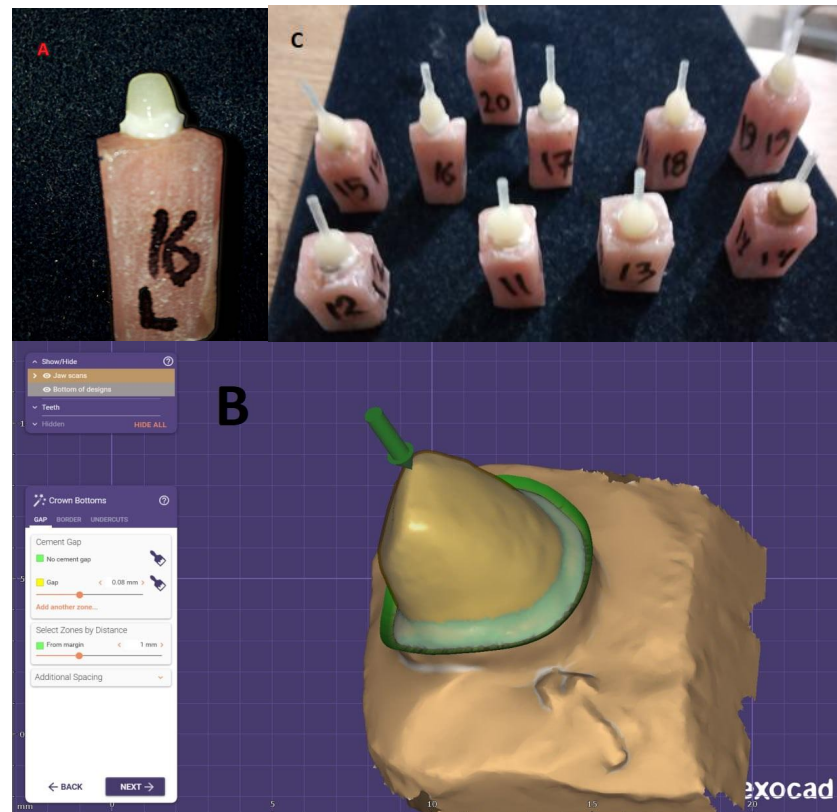
Fig. (2). **A)** One of the abutments from group two. **B)** Occlusal view and measurement of the finish line width of one of the abutments from Group Two after scanning with the optical scanner. **C)** Specimens of Group II.

The coronal portion of each specimen was rebuilt using a composite resin core. Dentin was etched with 37% phosphoric acid (Eco-Etch, Ivoclar Vivadent, Liechtenstein) for 15 seconds, rinsed, and dried with oil-free air. A universal bonding agent (Tetric N-Bond Universal, Ivoclar Vivadent, Liechtenstein) was applied and light-cured for 15 seconds. The core was built incrementally using a nanohybrid composite (Tetric N-Ceram, Lot 23503, Ivoclar Vivadent, Liechtenstein), with each layer not exceeding 1.5-2 mm in thickness. Each increment was light-cured individually for 40 seconds using the same LED curing unit. After completing the core build-up (Fig. 2A), the preparation was refined using a round-ended tapered diamond bur to remove undercuts and ensure smooth continuity between the composite core and natural tooth structure (Fig. 2B and C) [12].

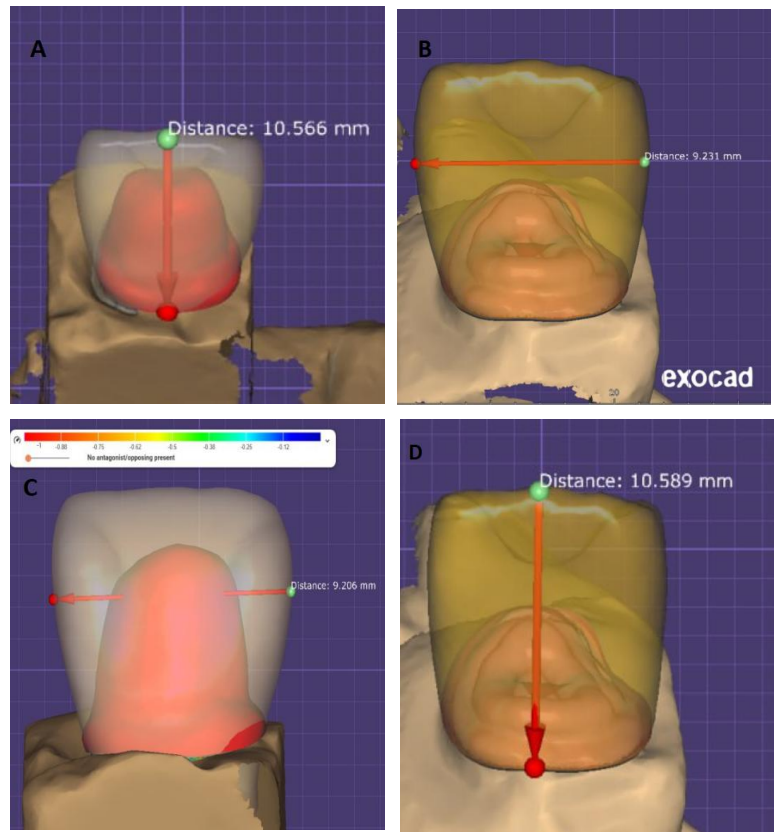
Fig. (3A-D). The measurements of the wax models before milling.

2.6. Standardized Tooth Dimensions in Group II (Fig. 3)

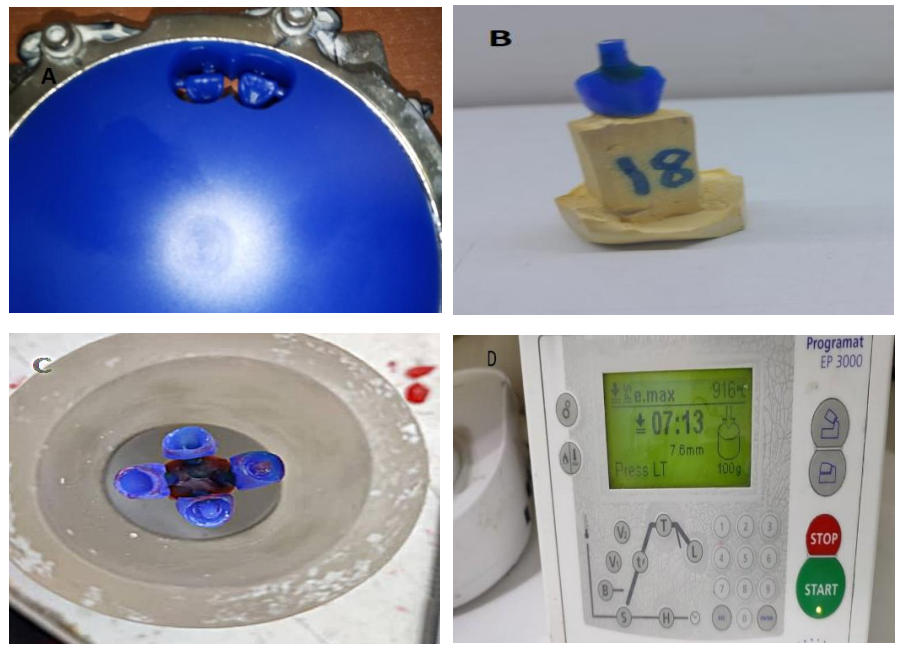
Fig. (4). A) Wax disc milling. B) Wax model anchoring. C) Final waxing with pins on the injection crucible base. D) Setting up the thermal injection device.

(ROLAND® DGSHAPE DWX-52DCI) to produce standardized wax patterns with a 40- μ m cement space. Margins were sealed with casting wax (Renfert), and 3-mm wax sprues (Renfert) were attached following the manufacturer's recommendations (Fig. 4).

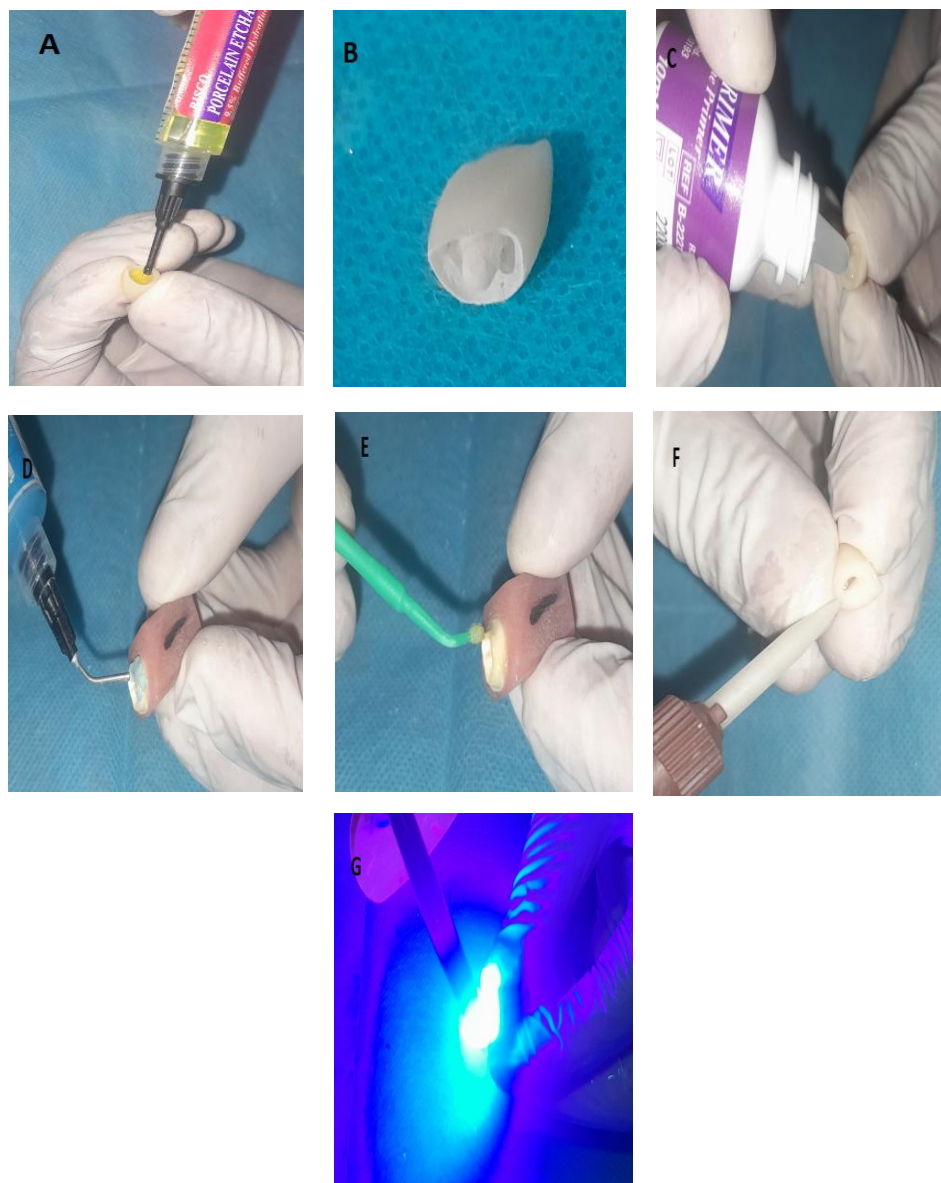
Fig. (5). **A)** Etching the internal surfaces of the restorations with 9.5% hydrofluoric acid. **B)** The chalky appearance of the porcelain after etching. **C)** Application of the dual bond agent (silane). **D)** Etching the abutments with 37% phosphoric acid. **E)** Applying bond. **F)** Application of the dual-cure resin cement. **G)** Curing the cement using a light-curing device.

instructions and applied to the internal surface of each restoration. Restorations were seated with light finger pressure, and excess cement was removed. Light curing was performed on the buccal, lingual, mesial, and distal aspects for 40 seconds per surface using the same LED curing unit (Fig. 5).

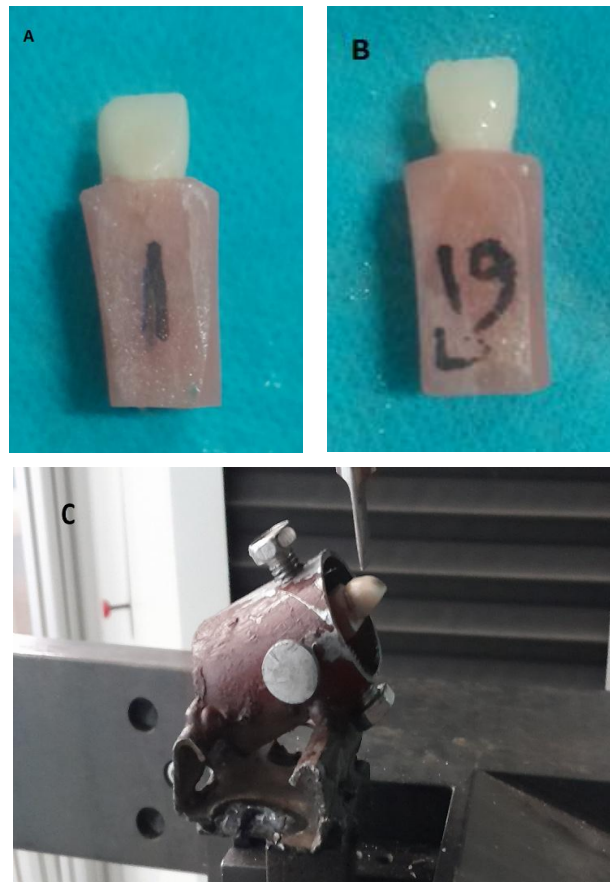
Fig. (6). (A and B) The final restoration after bonding. C) Applying oblique forces to the teeth at a 45-degree angle on a custom-made base.

All specimens were stored in physiological saline solution for 48 hours before mechanical testing (Fig. 6A-C). A comparison between the two groups is presented in Fig. (7).

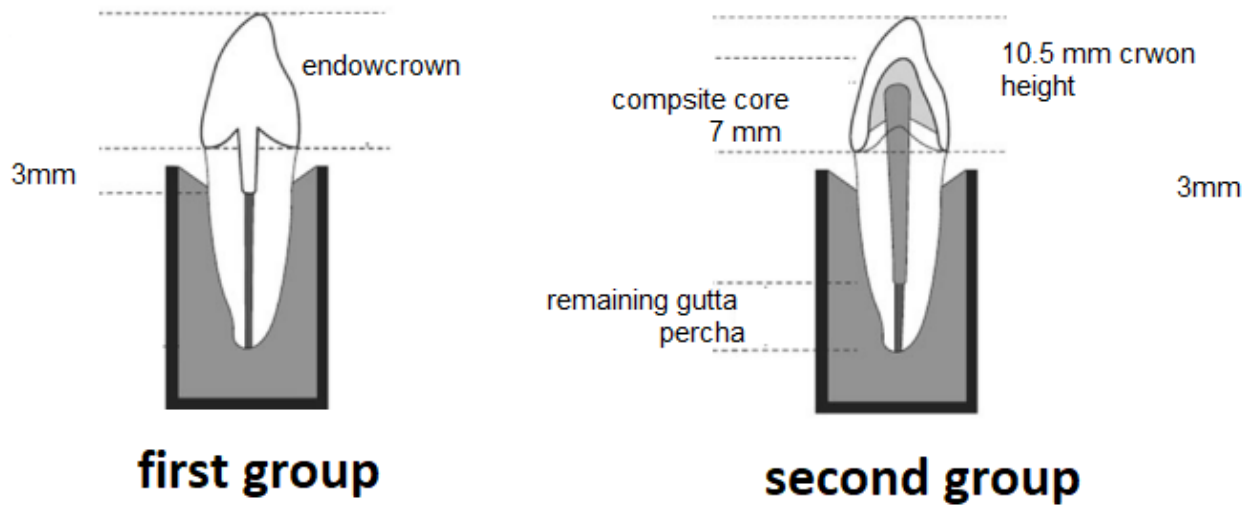
Fig. (7). Illustrates the final compound for both study groups.

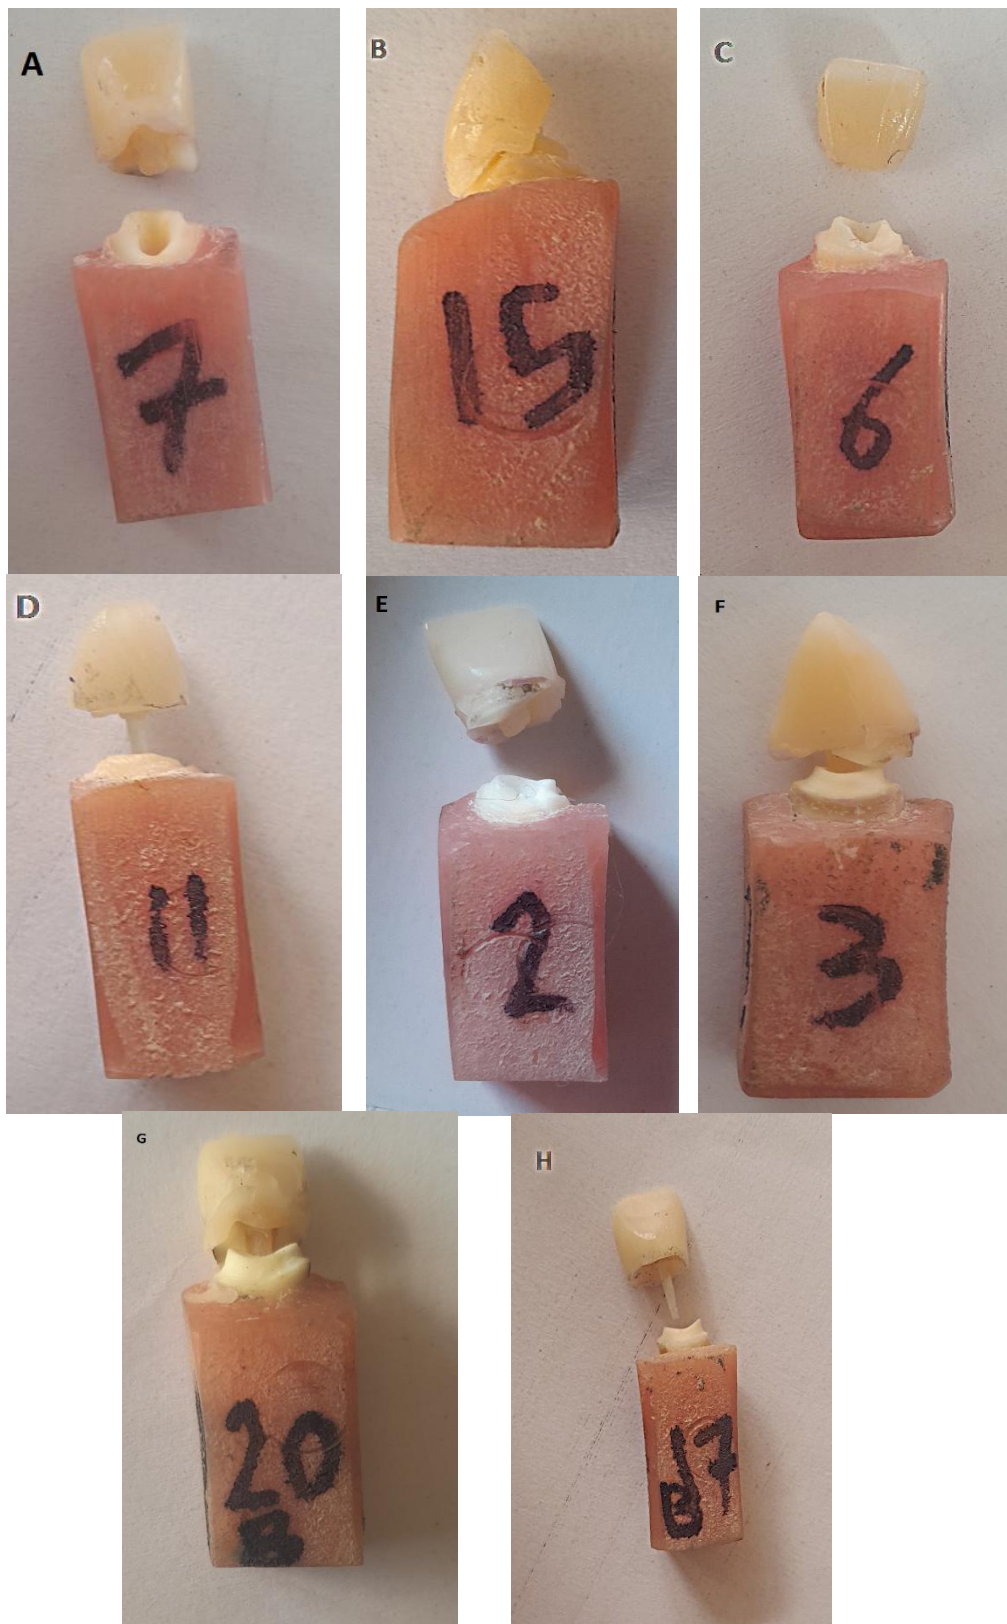
Fig. (8). (A and B) Fracture of the restoration and tooth below the CEJ. (C and D) Fracture of the restoration and tooth above the CEJ. (E) Fracture of the tooth below the CEJ. (F and G) Fracture of the restoration only. (H) Debonding of the restoration.

The following patterns were identified: Fracture of the restoration and tooth below the CEJ (Fig 8A and B); fracture of the restoration and tooth above the CEJ (Fig. 8C and D); fracture of the tooth below the CEJ (Fig. 8E); fracture of the restoration only (Fig. 8F and G); and debonding of the restoration (Fig. 8H).

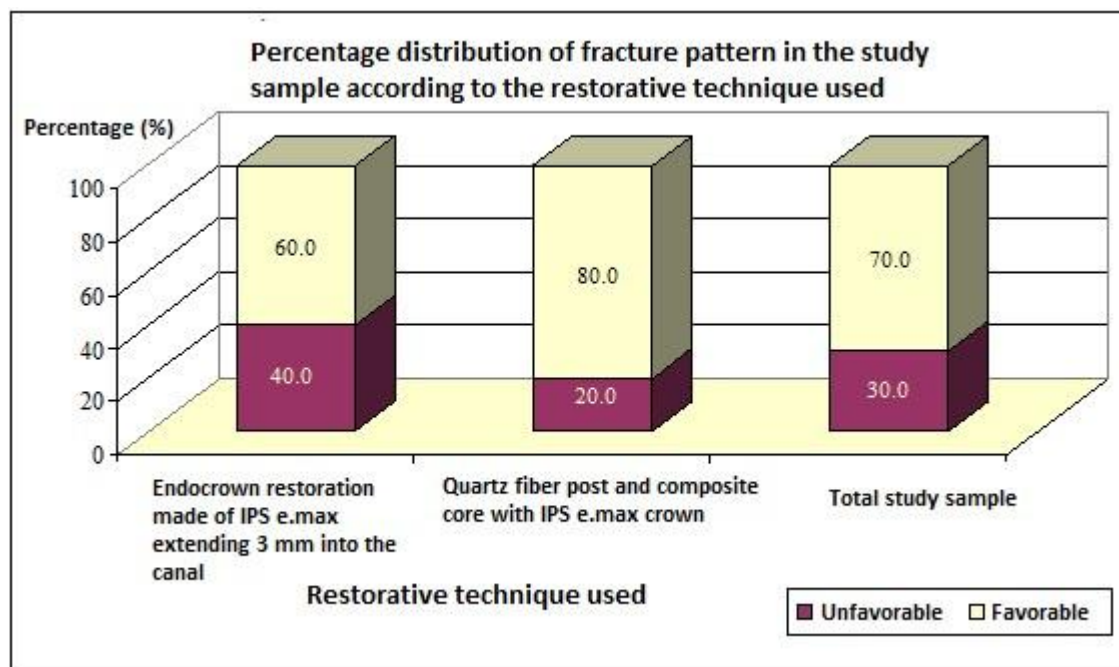
Fig. (9). Percentage distribution of the results of the nature of fractures in the study sample according to the restorative technique used.

Fractures were further classified as favorable or unfavorable based on their clinical reparability. The distribution of fracture types relative to restorative technique is illustrated in Fig. (9).
